Bain Property Inspection, Inc.

Property Inspection Report

For Sarah Hendricks
220 Perino Road, Lexington, KY
October 25, 2011

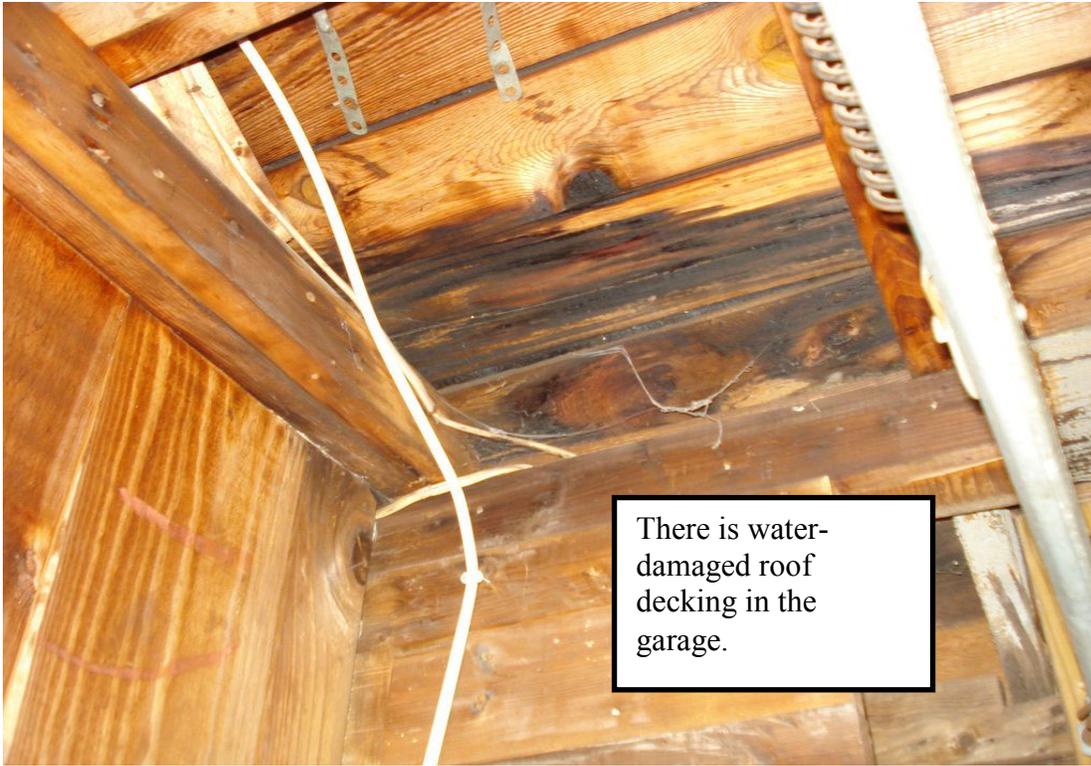
There is water-damaged roof decking in the garage.

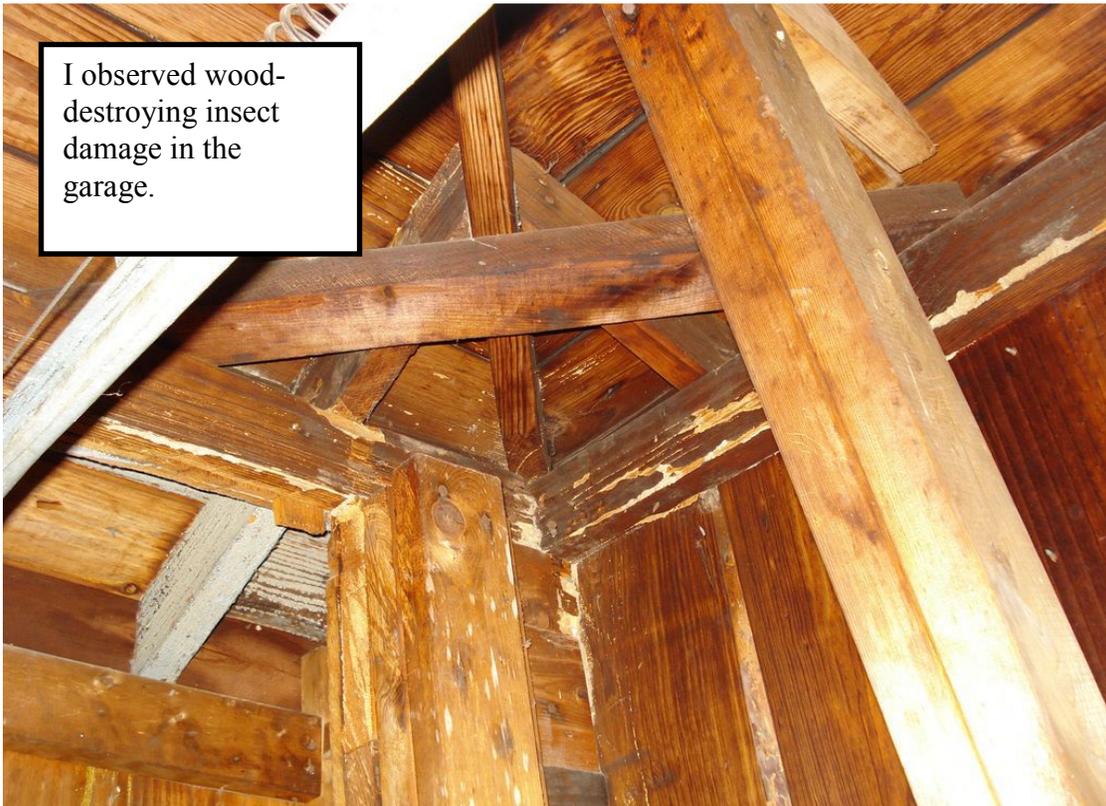
- e) There appears to be wood-destroying insect damage in the front/left corner of the left garage.
 - f) The 2" x 4" rafters within both garage bays were excessively notched to accommodate the vehicular doors. Pier and beam systems have been installed to mitigate this condition, but the front portions of the roof framing should be reinforced.

I observed wood-destroying insect damage in the garage.

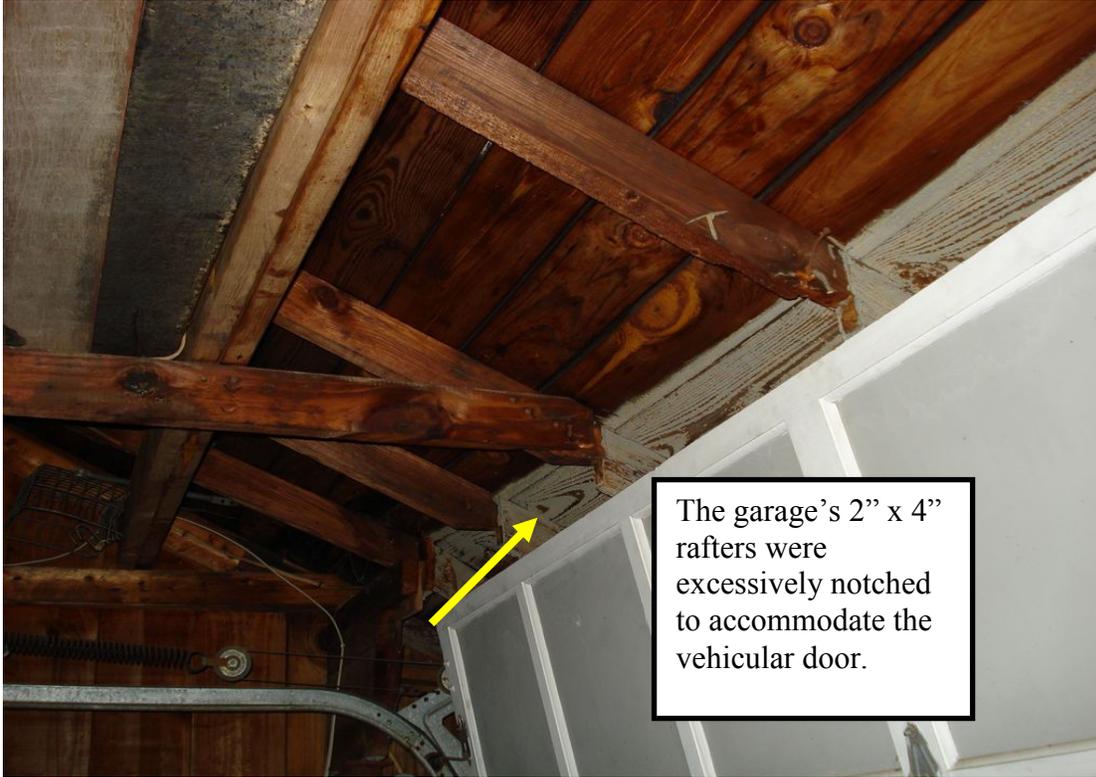
The garage's 2" x 4" rafters were excessively notched to accommodate the vehicular door.

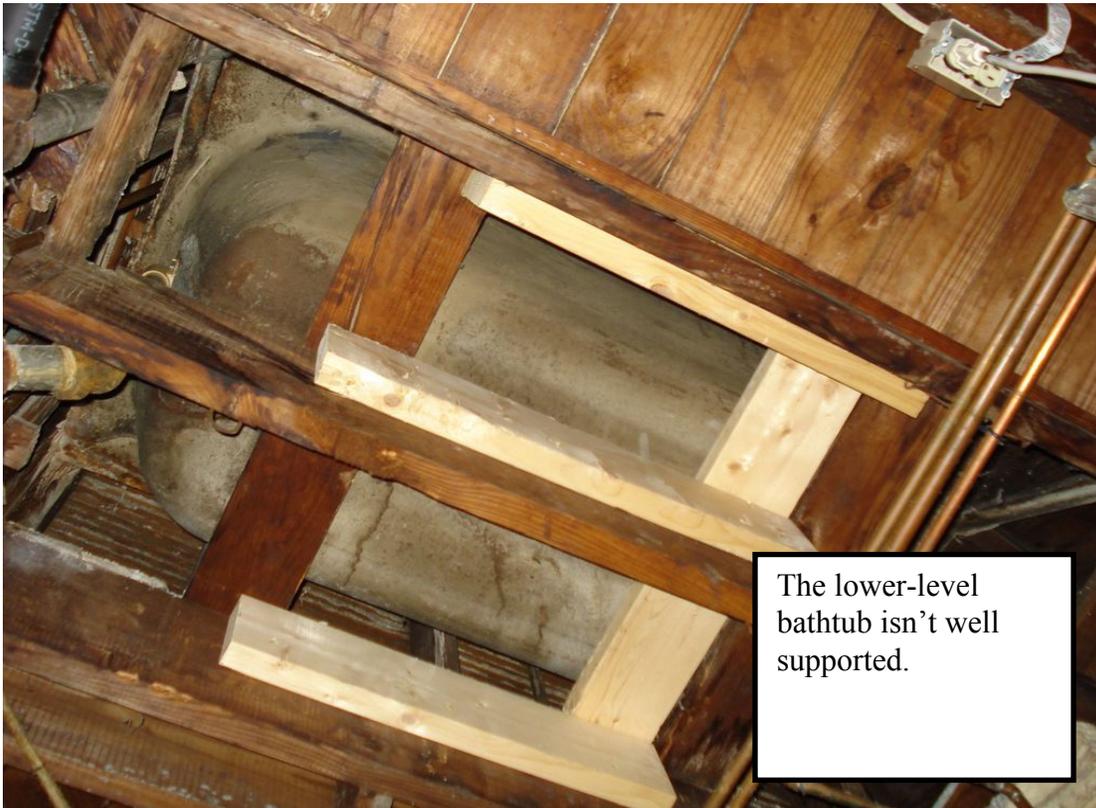
The lower-level bathtub isn't well supported.

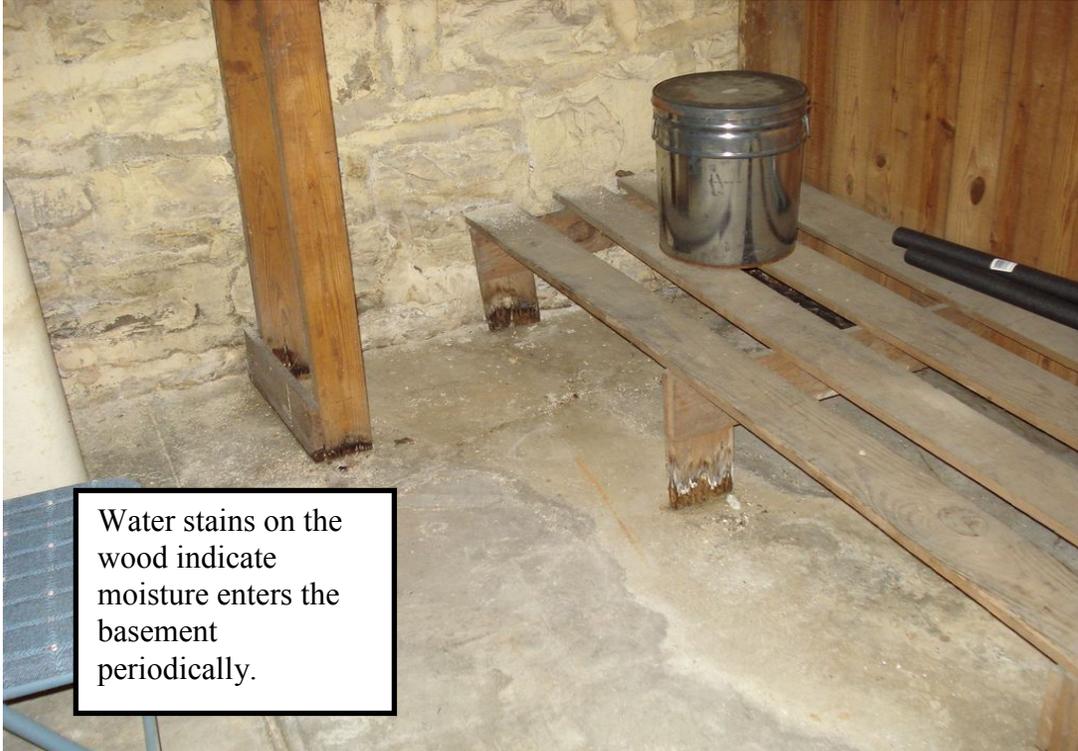
Water stains on the wood indicate moisture enters the basement periodically.

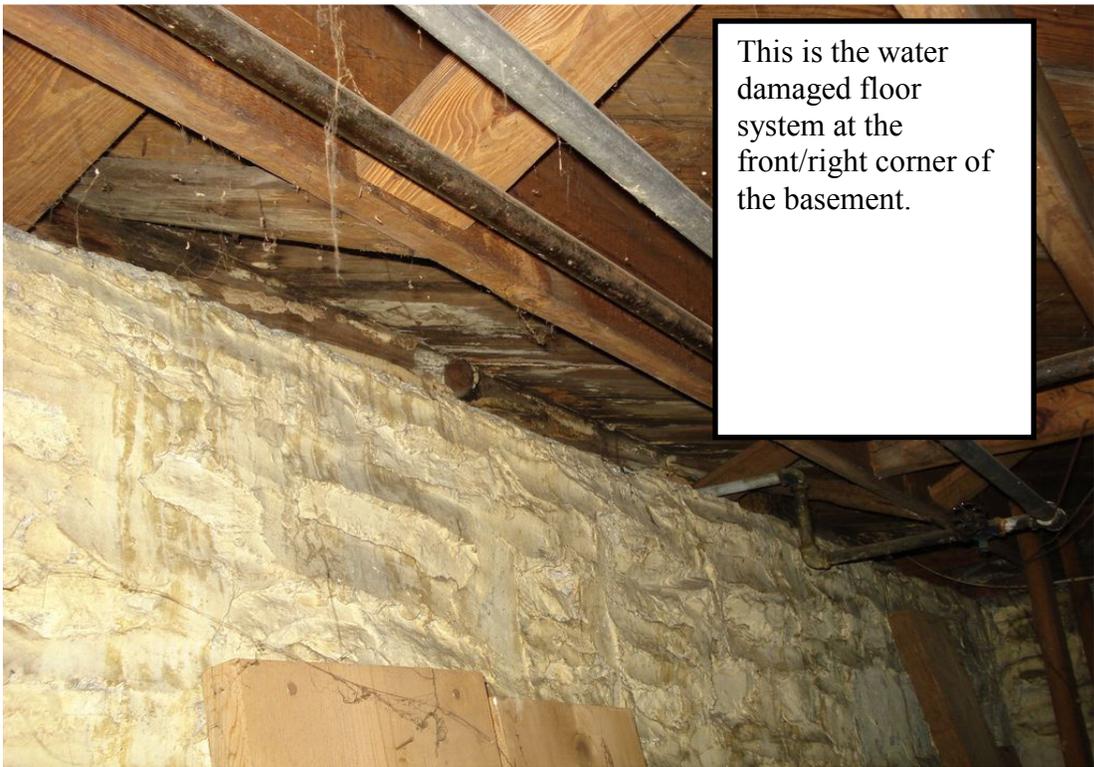
- 2) The front/right portion of the main-level floor system has sustained water damage in the past, likely due to failed clay downspout-extensions. It appears that the clay extensions have been replaced with PVC because of this condition.

This is the water damaged floor system at the front/right corner of the basement.

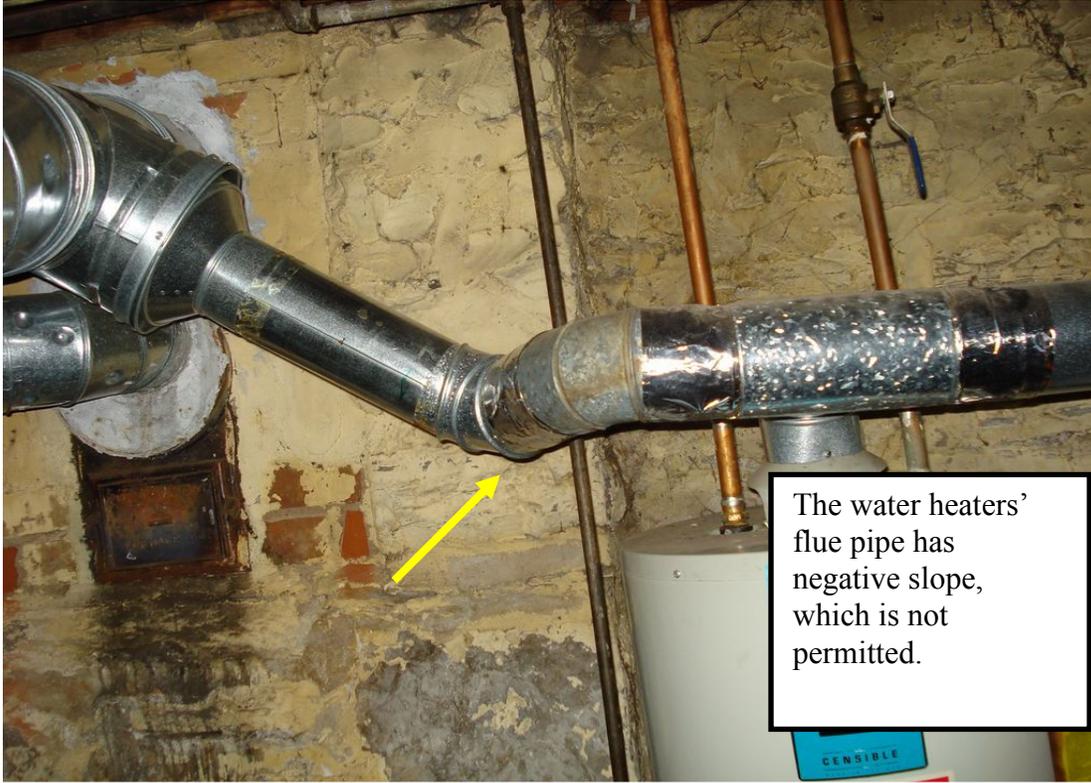
- 21) The basement clothes washer drain is improperly sloped.
- 22) Both water heaters are backdrafting flue gases into the basement, a potentially lethal condition. The draft hood for the left heater is partially detached, and the shared flue pipe for the heaters improperly slopes downward.

The water heaters' flue pipe has negative slope, which is not permitted.

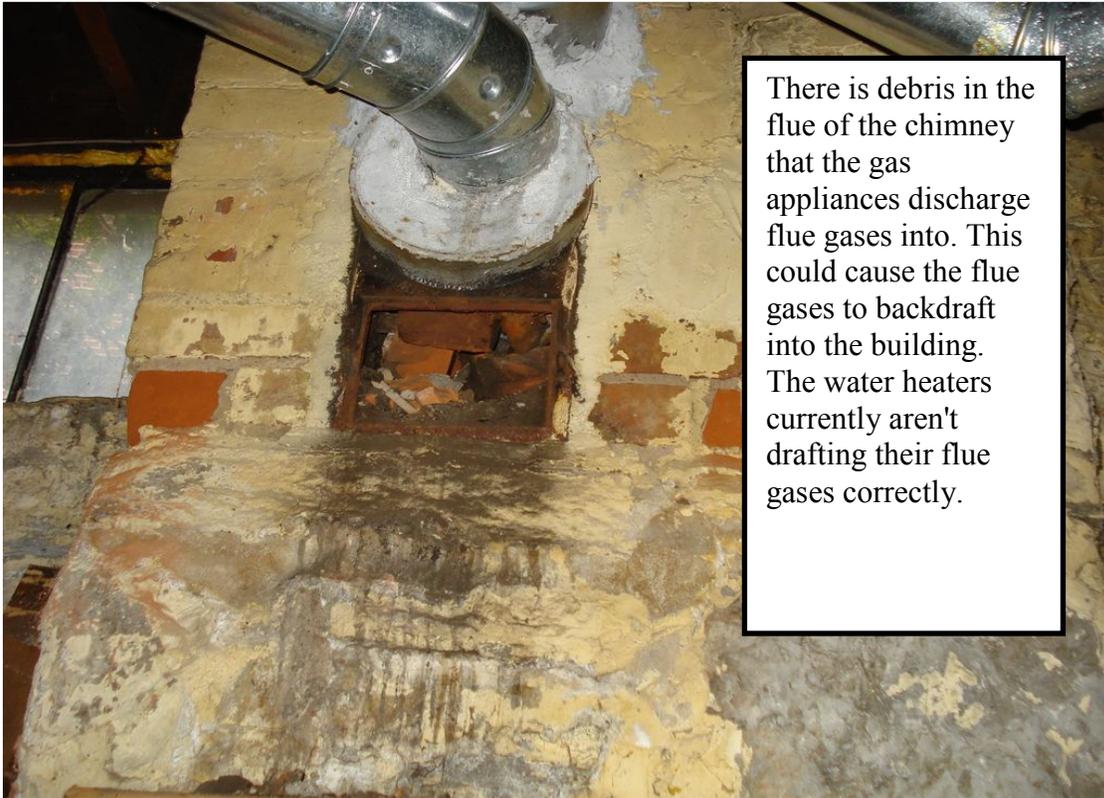
There is debris in the flue of the chimney that the gas appliances discharge flue gases into. This could cause the flue gases to backdraft into the building. The water heaters currently aren't drafting their flue gases correctly.

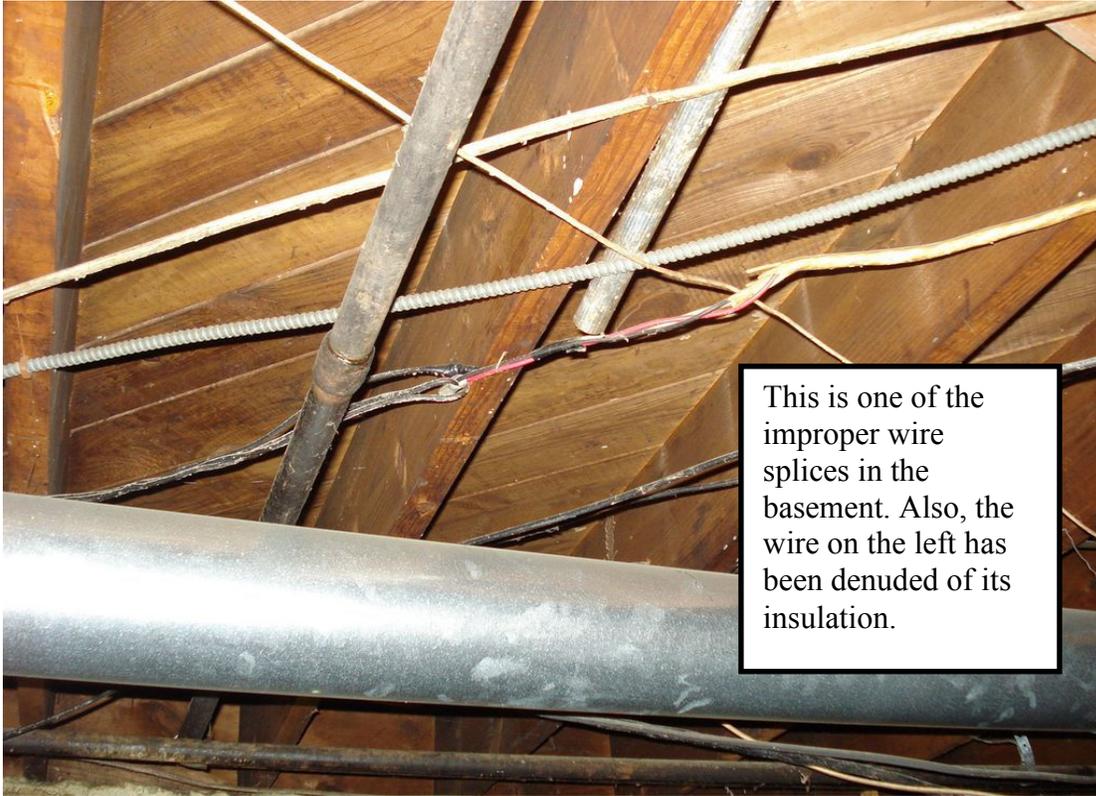
This is one of the improper wire splices in the basement. Also, the wire on the left has been denuded of its insulation.

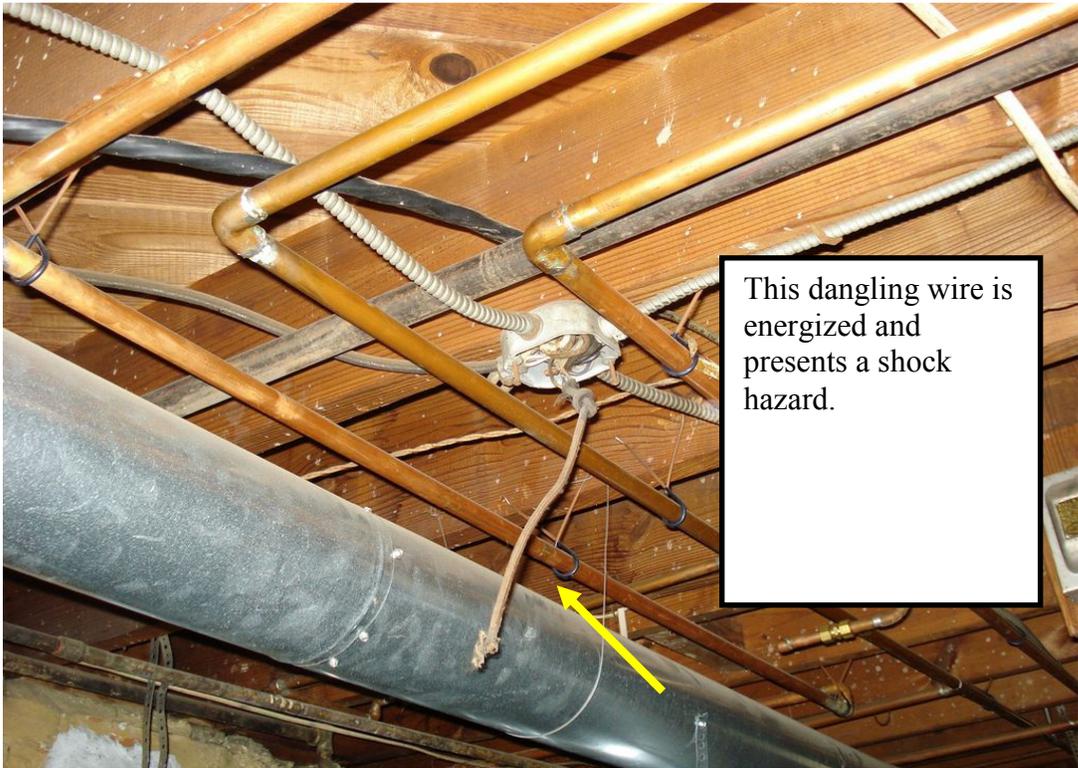
This dangling wire is energized and presents a shock hazard.

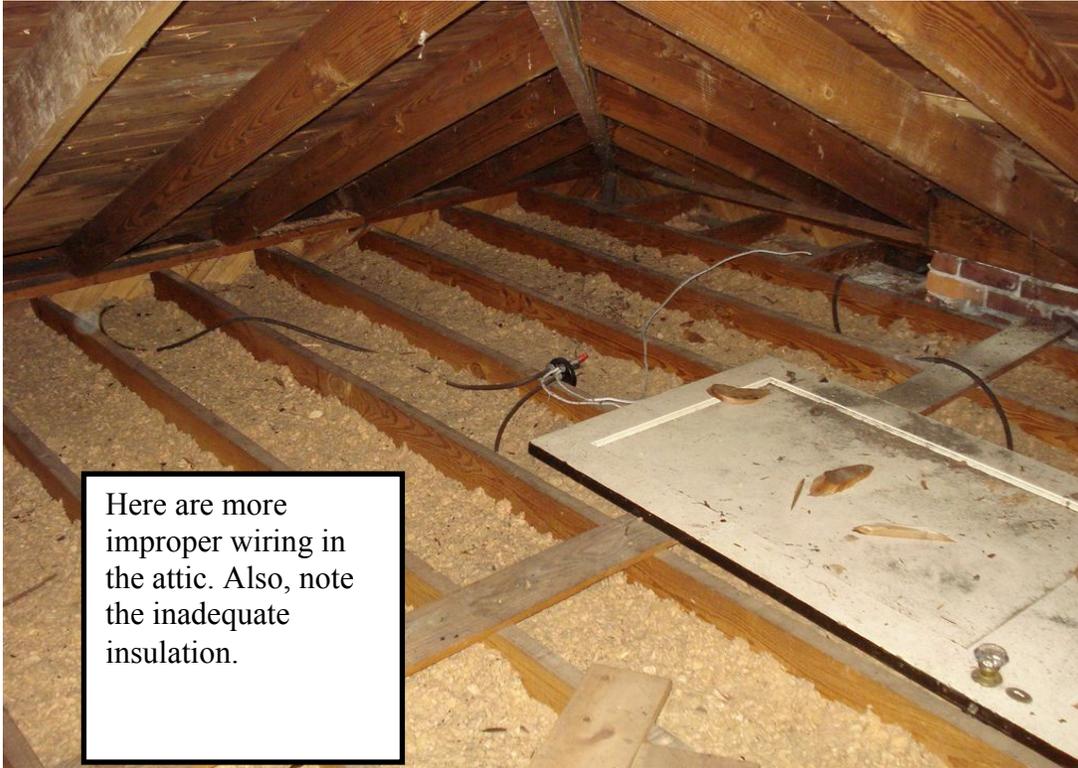
Here are more improper wiring in the attic. Also, note the inadequate insulation.

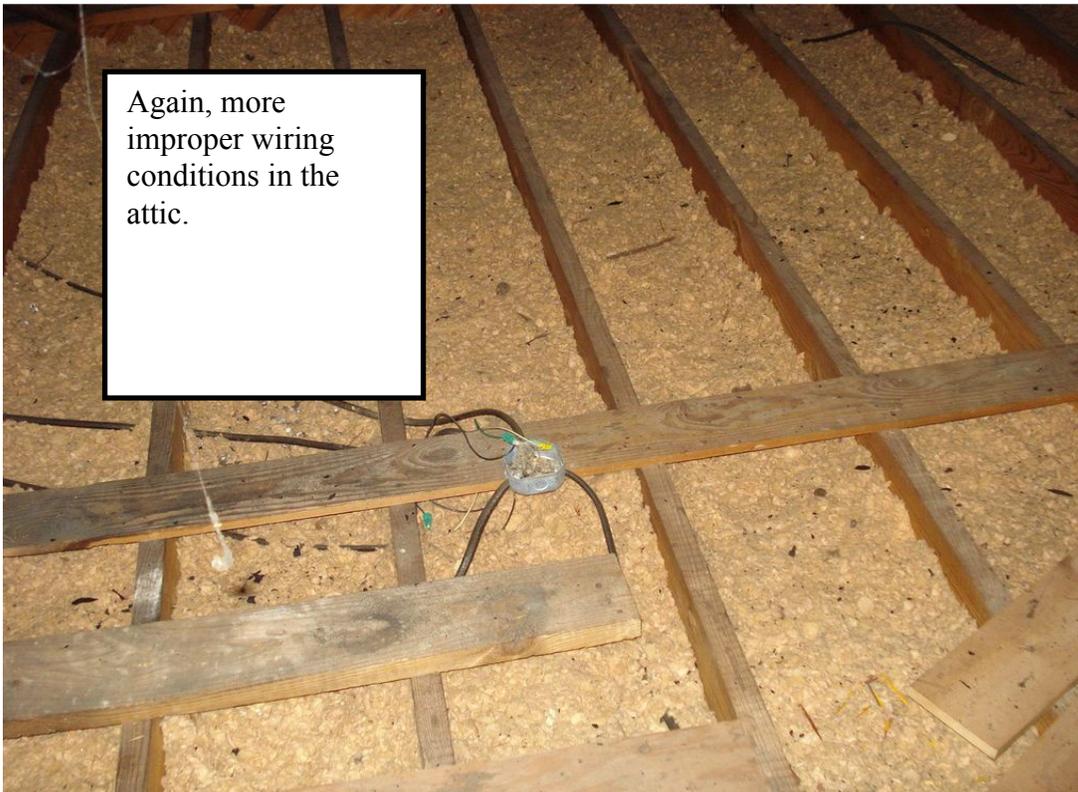
Again, more improper wiring conditions in the attic.

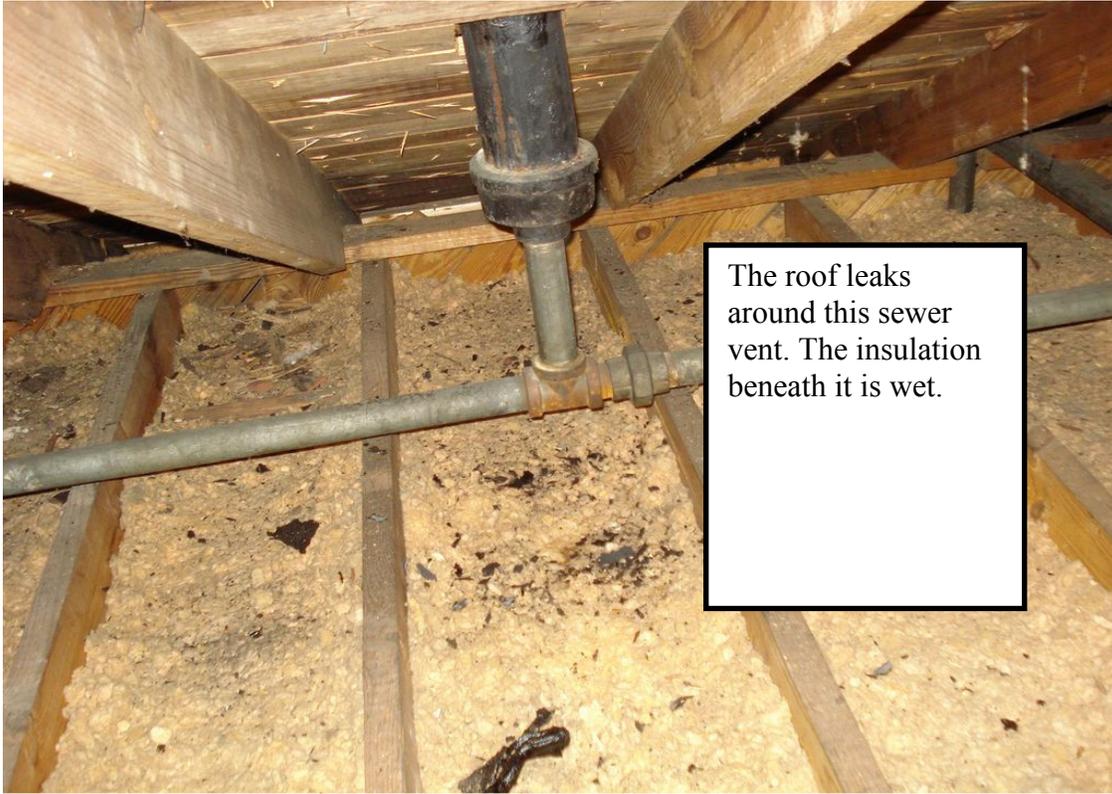
- 55) See above. The garage roof is near the end of its economic life and will require replacement soon.
- 56) The building's roof is leaking around the left/rear sewer vent. The insulation beneath the vent was damp to the touch.

The roof leaks around this sewer vent. The insulation beneath it is wet.

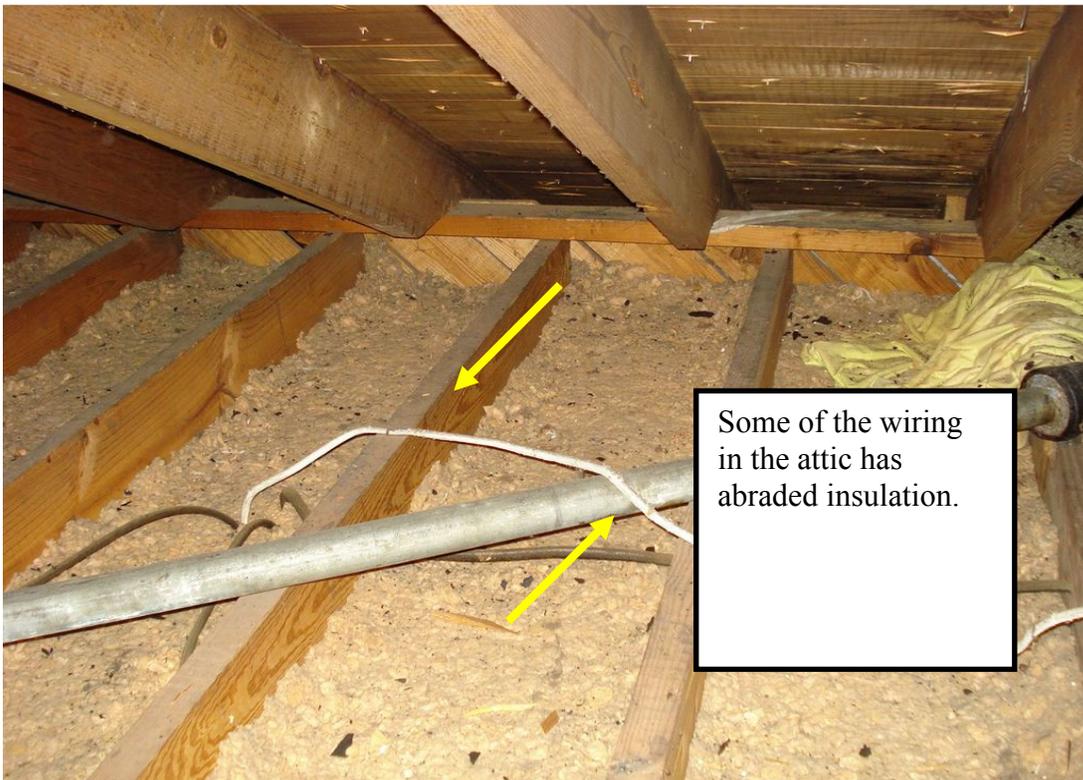
Some of the wiring in the attic has abraded insulation.

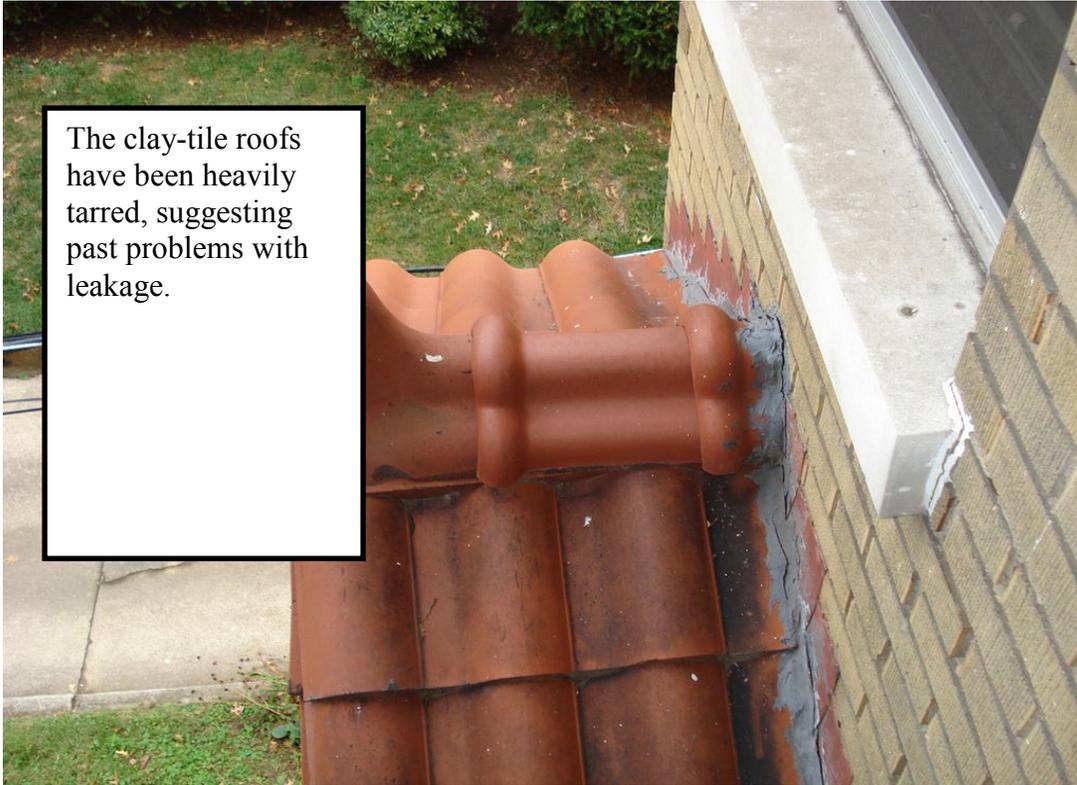
The clay-tile roofs have been heavily tarred, suggesting past problems with leakage.

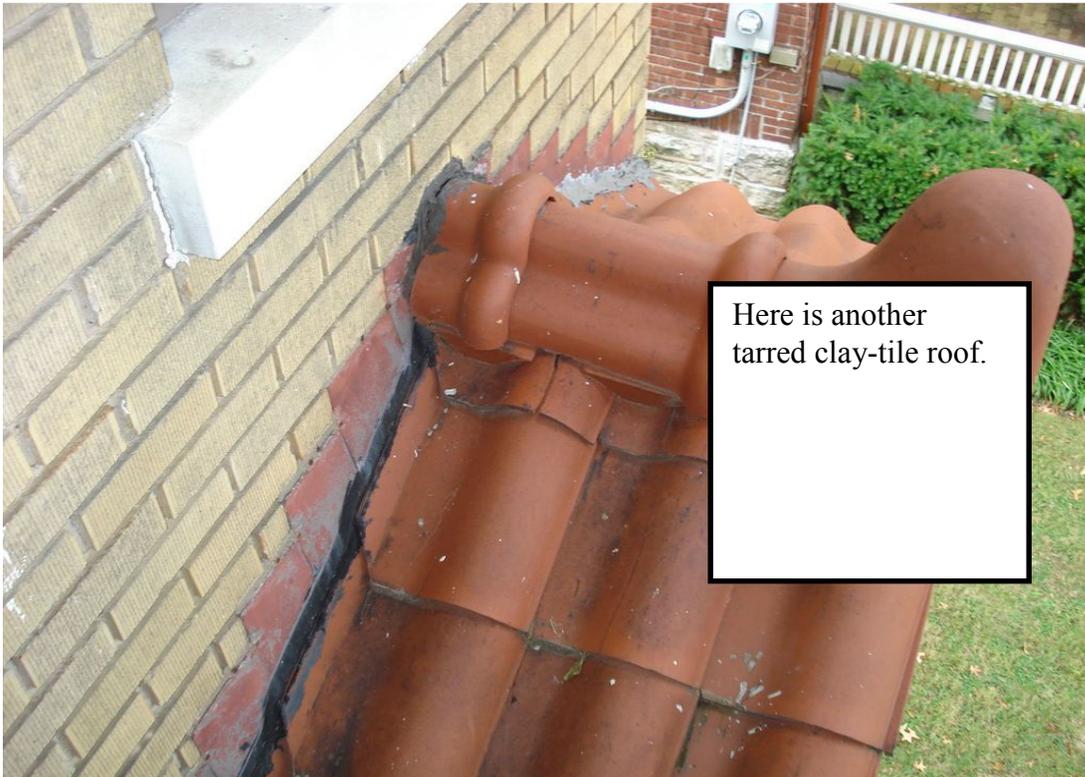
Here is another tarred clay-tile roof.

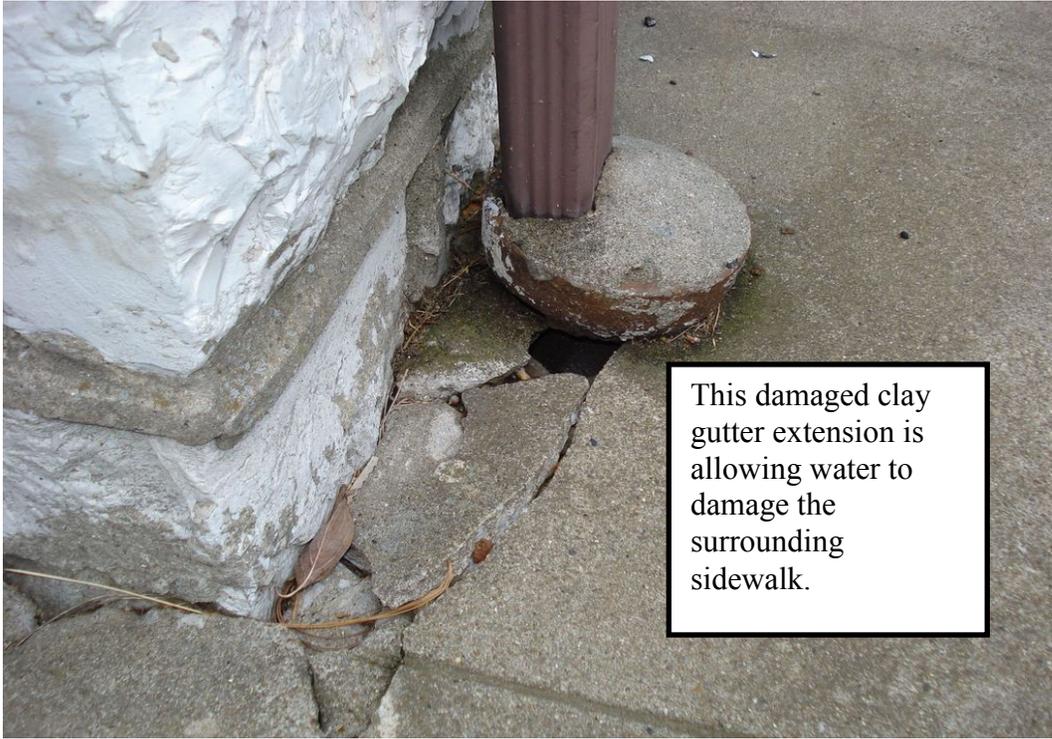
This damaged clay gutter extension is allowing water to damage the surrounding sidewalk.
